Surge Arrester Faults and Their Causes at EThekwini Electricity

M. Gumede and G. Frederick d’Almaine

Durban University of Technology/Power Engineering, Durban, South Africa

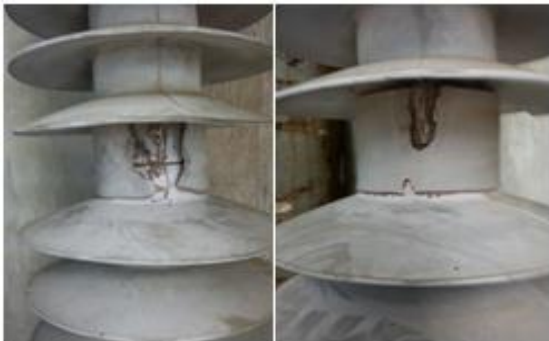
- Damage of sealing due to thermal heating produced inside varistor (see Fig. 8)

Figure 8. Defective sealing increase high rate of moisture ingress.

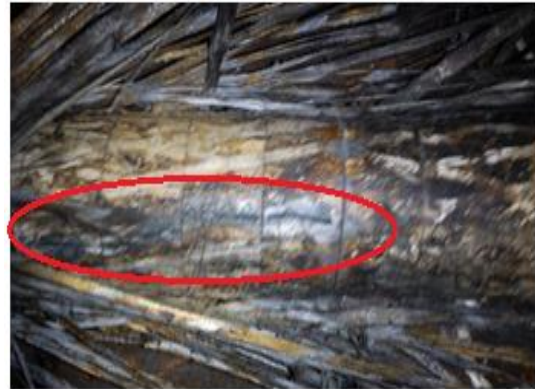
- Mechanical fractures in ZnO varistor due to thermal runaway after a high current surge (see Fig. 10)

Figure 10. Mechanical cracks in varistor elements.

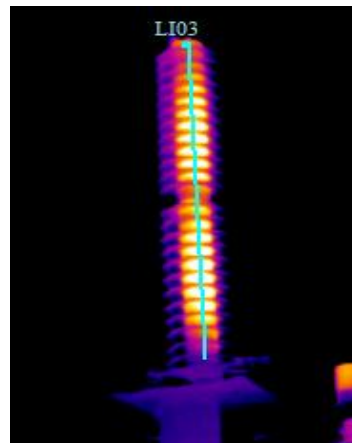
During the field trail analysis the results of failing arresters were obtained. Images of surge arresters showed the high rate of thermal heat. Results showed the thermal image and temperature profile of surge arresters tested, (see Fig. 12-Fig. 14). Note that the yellow in center of the image is a hot spot. This designates that instant de-energization and replacement must be undertaken before they failure.

Figure 14. Thermal image of arrester and temperature profile along the arrester.

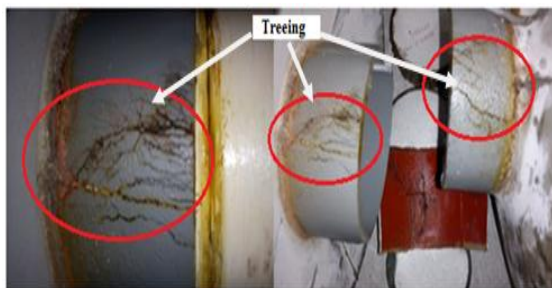
The results obtained during the visual inspection of the surge arresters of manufacturer A, (see Fig. 15-Fig. 18). The moisture ingress through the sealing collar causes serious problems such as surface discharges. These factors can eventually end with a full breakdown over the insulation system. Water treeing inside the sealing collar was noted as were cracks on the zinc oxide blocks closest to the sealing, this indicates that that the failing started here.

Figure 16. Water treeing on the sealing collar.
